NSWC/WOL/TR-78-39

**FEASIBILITY OF ULTRASONIC RAYLEIGH
WAVES FOR THE DETECTION OF
CORROSION BENEATH PAINT**

BY ROBERT A. YOUSHAU

7 FEBRUARY 1978

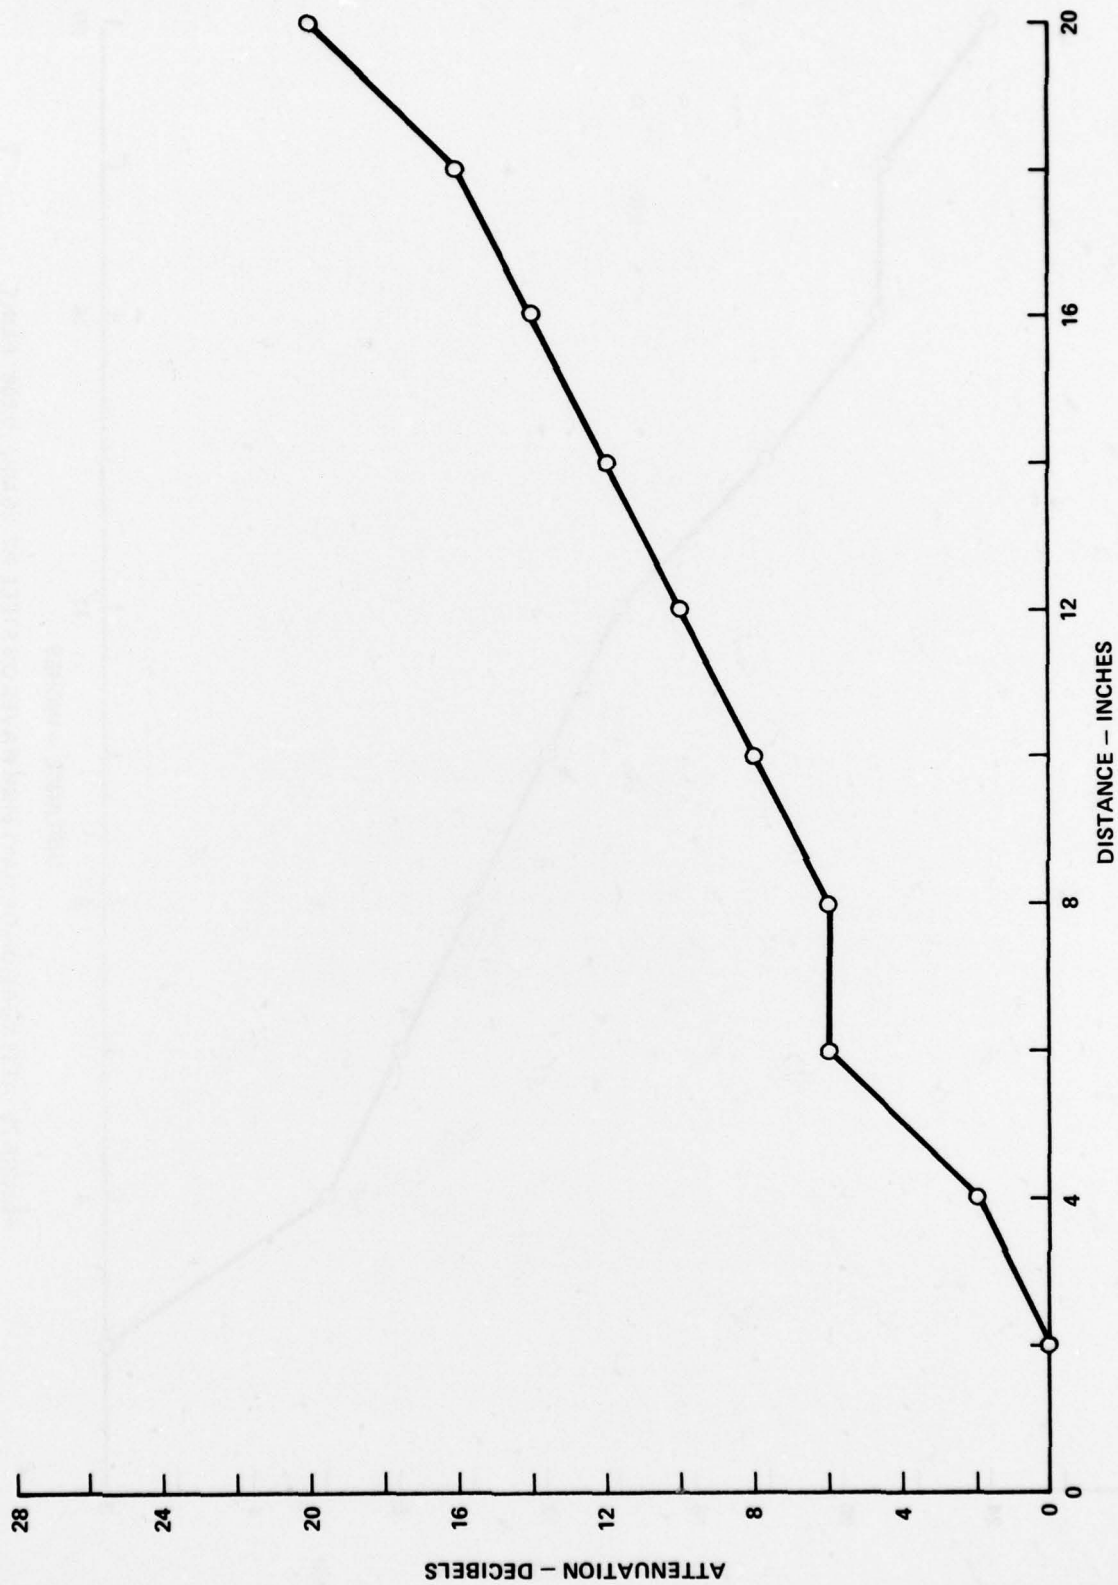
FIGURE 2D ATTENUATION OF RAYLEIGH WAVES ON STEEL AT 1.0 MHz, 0.005 " PAINT.

Attenuation measurements were made at 2.25 MHz, Figures 1(A-E) and 1.0 MHz, Figures 2(A-E) using the pulse-echo technique and the perpendicular edge of the steel plate as the reflector. An attempt to obtain similar data at 5.0 MHz was not successful due to extreme attenuation at that frequency. In a separate experiment, the distance was maintained constant at 10 inches and the attenuation in decibels was plotted against the paint thickness, Figure 3. The effect of frequency is readily seen and also that the full dry film thickness of eight mils is extremely absorbing at 2.25 MHz which effectively limits the inspection distance to about ten inches.
